VIDEO MOTION DETECTION FOR REAL-TIME HAZARD WARNINGS IN SURFACE MINES

Edward L. McHugh

Spokane Research Laboratory, National Institute for Occupational Safety and Health, Spokane, Washington, USA

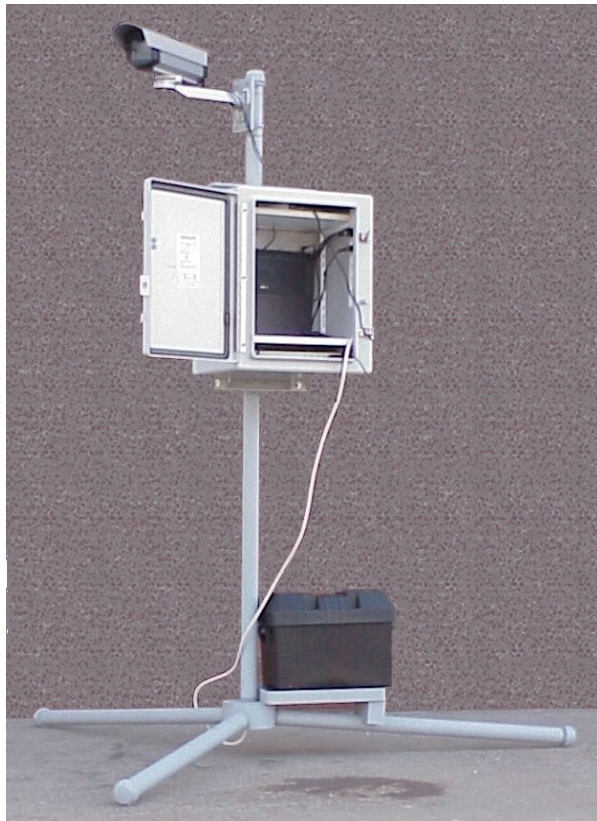
Figure 1.—Video motion-detection system showing camera, electronics enclosure, and 12-V battery on a tripod.

corded video images. All of these off-the-shelf components are powered from a 12-V, 100-amp-hour, deep-cycle battery by way of a 140-W dc-ac inverter. The computer, camera controls, and power connections were installed in a fiberglass environmental enclosure. The enclosure and a mount for the camera were attached to a 2-m-long, 38-mm diameter steel mast screwed into a three-legged base (figure 1). The camera was mounted near the top of the mast in its own weather enclosure.

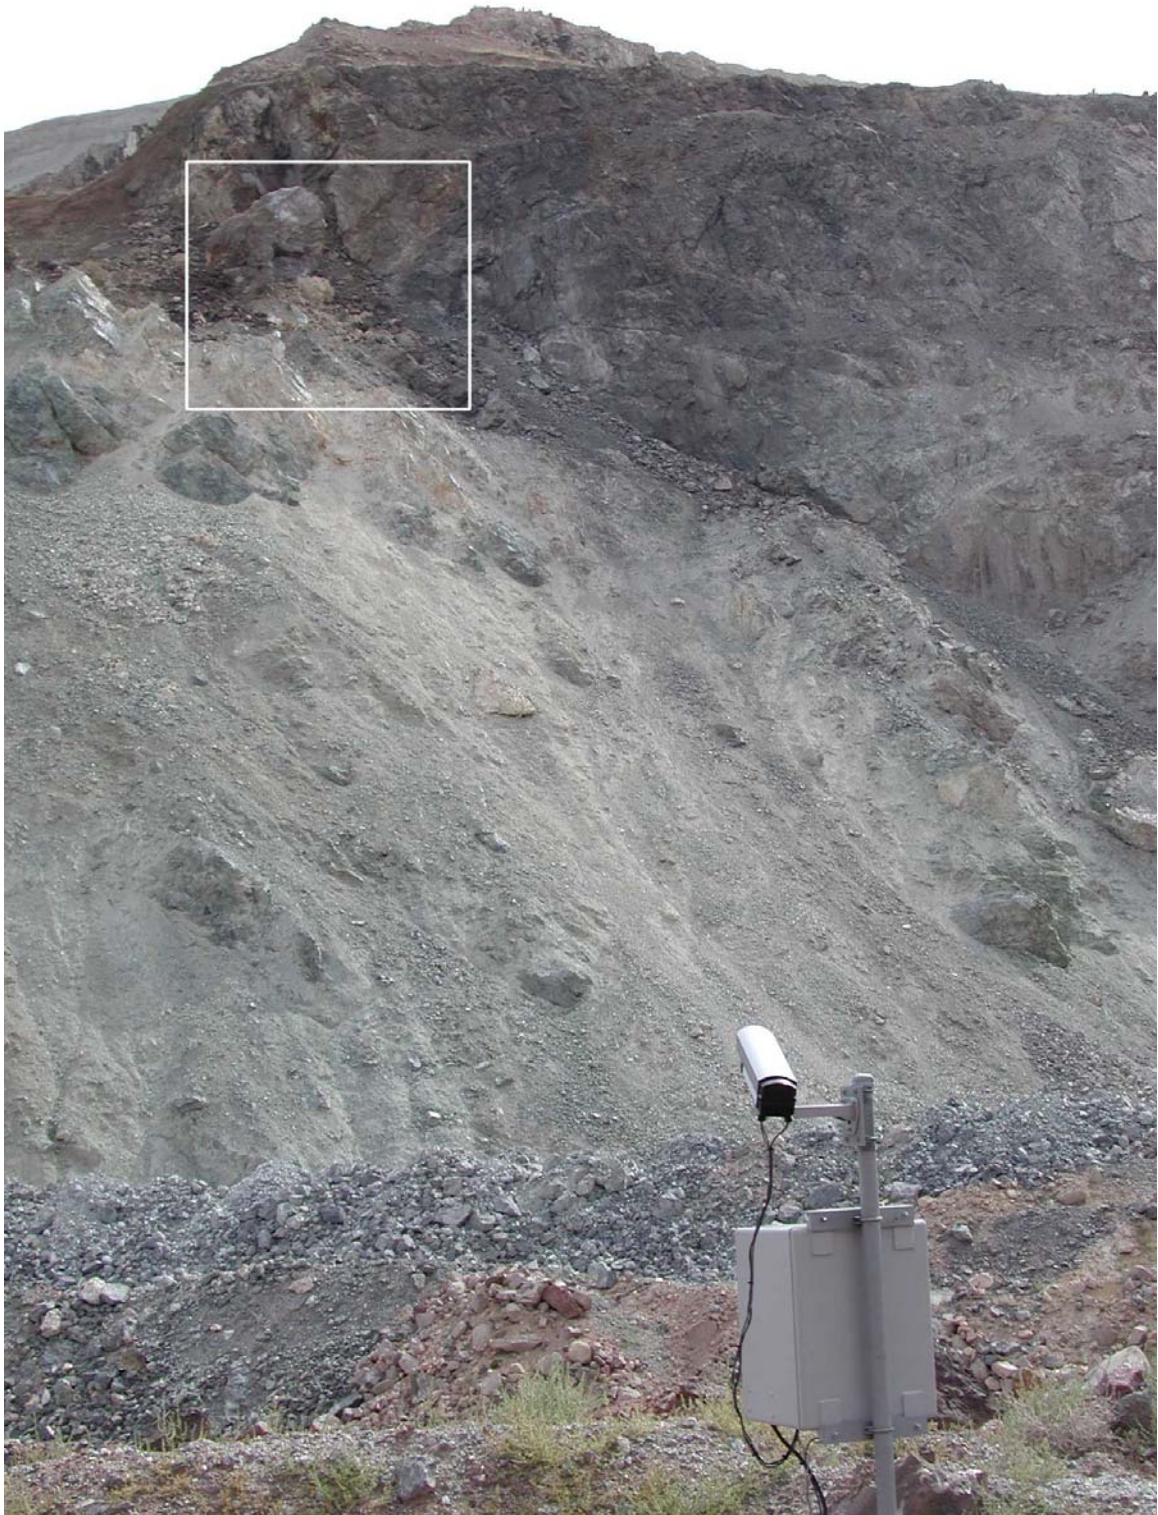
Figure 4.—Highwall at the Yellowstone Mine showing area monitored by video camera (white box).

At the Yellowstone Mine, the motion detection camera was trained on a portion of the highwall, at a range of 134 m, where rockfall had occurred recently (figure 4). No rockfall activity was detected over a 2-day period, but rocks were dropped from above into the image area to generate rockfalls. Each of these was captured in two events totaling 220 frames. Figure 5 shows a video frame that includes the impact of a dropped rock. The rock in motion (blurred) and a small cloud of dust were sufficient to be detected by the system.

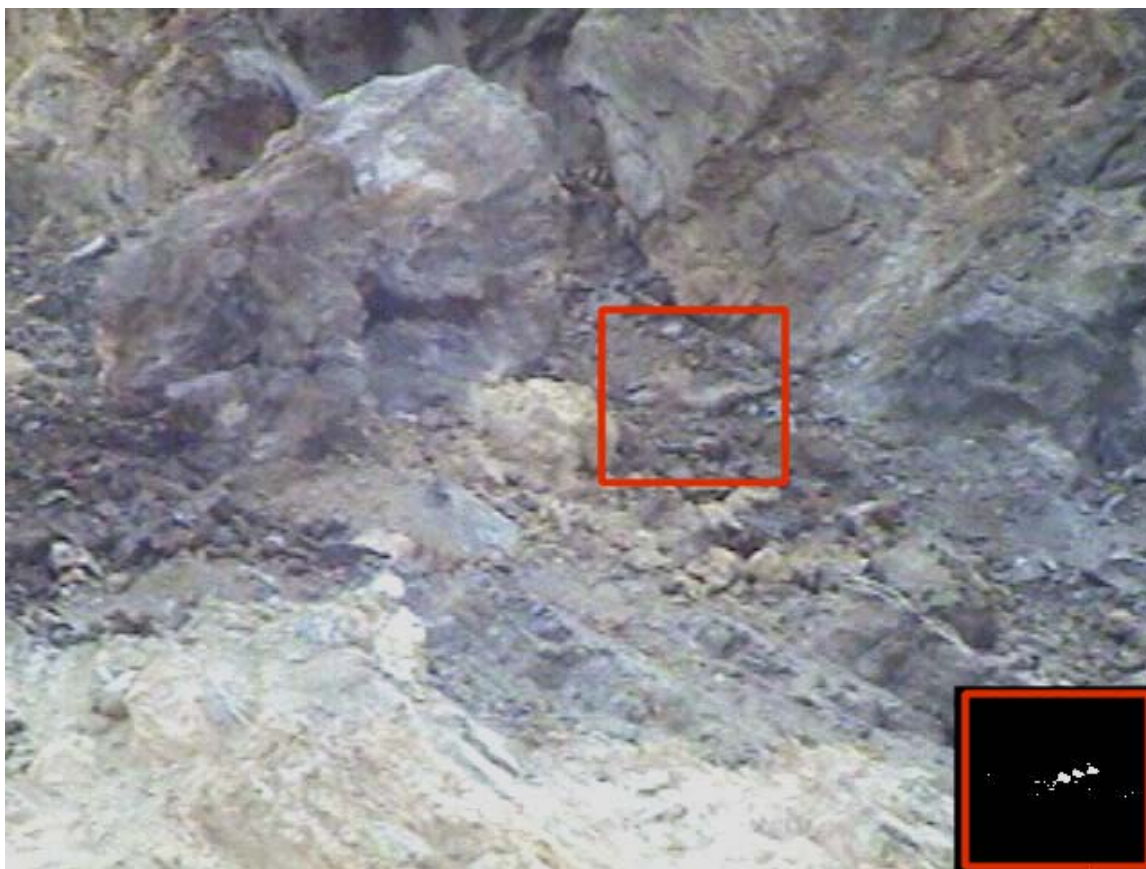
Figure 5.—Video frame captured during detection of a rockfall. Box shows where rock impact was detected. Inset shows where in the box differencing with a previous frame revealed changed pixels.

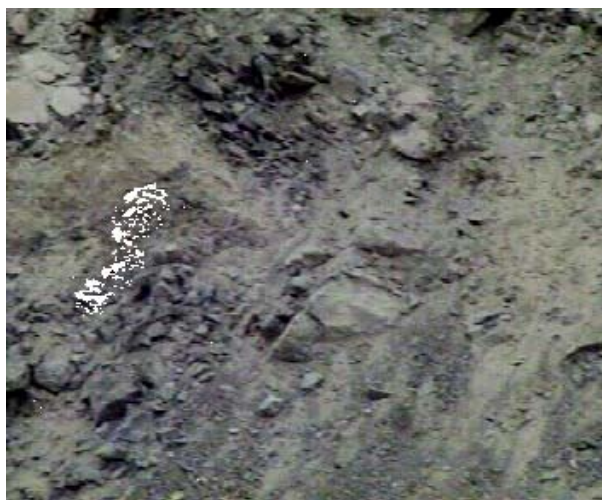
Figure 7.—Video frame captured during detection of rockfall in area of box shown in figure 6. Bright areas show where change was detected.

39 m and resolution was 640 by 480 pixels. For 16 events at this resolution, nine were manual triggers during set-up and testing, five were apparently wind induced, and two captured small-scale sloughs on the slope. In a second configuration, the camera was focused in on a part of the rock face, and resolution was changed to 320 by 240 pixels; rocks were dropped or thrown onto the slope (figure 6). Three artificially induced rock falls totaling 252 frames were captured. In one event, three sequential rock impacts were followed by sloughing over a total of 72 frames and an elapsed time of 39 seconds (figure 7).

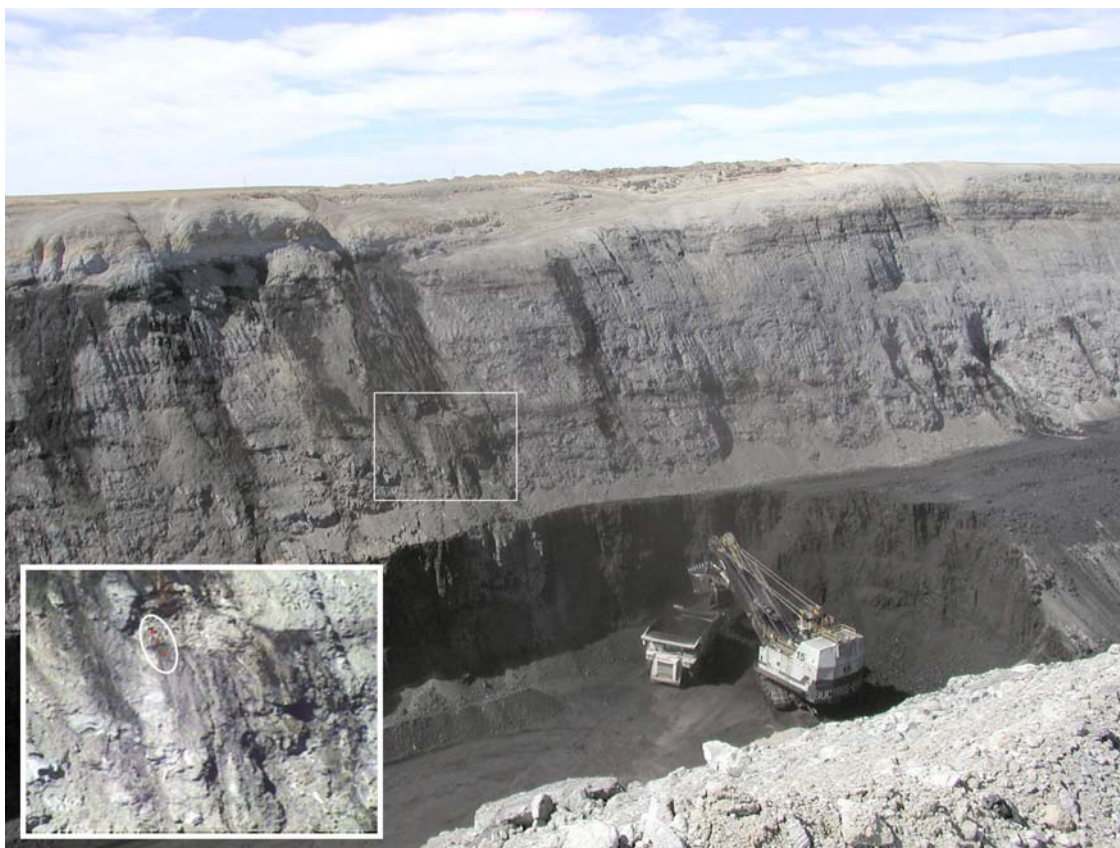
Figure 8.—Highwall at Black Thunder Mine. Box shows area of broken rock and water seepage monitored by video system. Inset shows video frame captured during detection of rockfall; area in oval shows where change was detected

In a second setting the camera was zoomed in on a zone of broken rock and water seepage about a third of the way down the highwall from the top (figure 8). In this position over a period of 10 hours of monitoring, rock movements were observed in 32 events resulting in 1073 frames recorded (33 frames per event). No rock movement was apparent in an additional 101 events that were likely caused by wind shake of the camera, averaging seven frames per event.

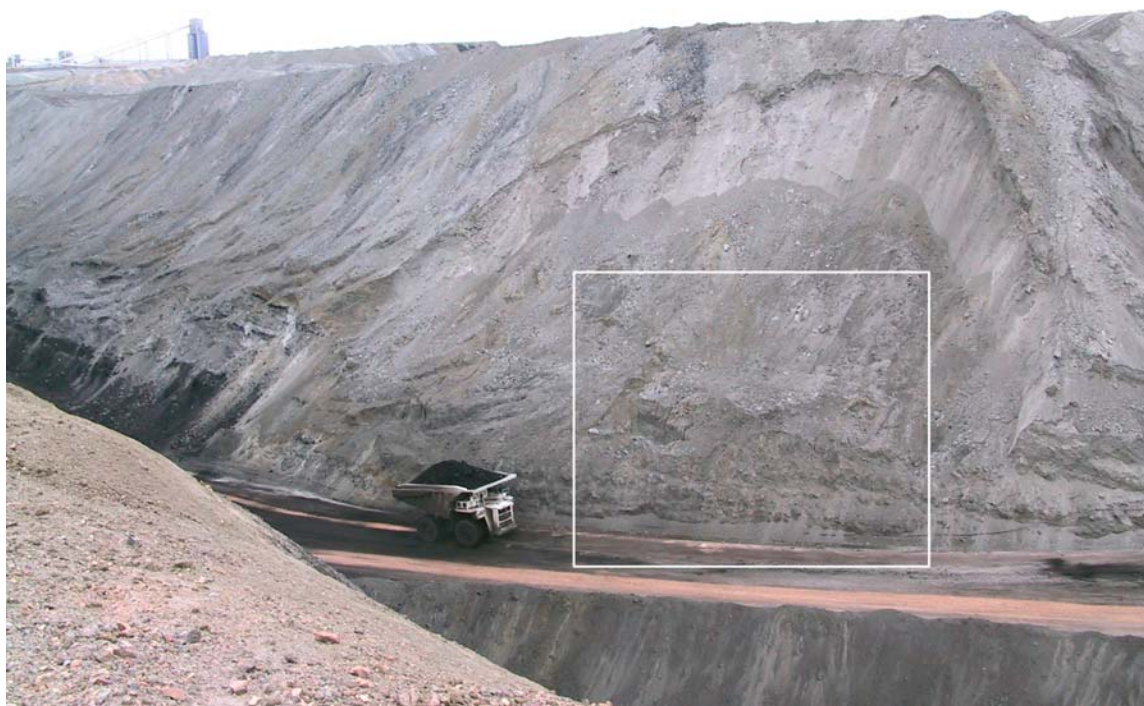
Figure 9.—Slump area in spoils at Black Thunder Mine. Box shows area covered by video monitor.

On day 3 at Black Thunder, the video system was positioned on the highwall side of the pit to view the spoil slope above a ramp intersection with the pit floor; range was 154 m. The view includes a spoil face where large-scale sloughing had occurred in recent weeks (figure 9). The video monitor was positioned to include a portion of the haul road along the pit floor so that vehicles using the road could trigger recording if no mask was used. The left video frame in figure 10, where the first parts of the haul truck are barely visible at the left edge, shows that even a very small change in the image can trigger recording. The right frame shows a mask within the image that would avoid vehicle-triggered alarms. Rock movement was detected in none of the 355 events recorded; moving vehicles (haul trucks, graders, loaders, scrapers, pickup trucks) accounted for 132 events, averaging 212 frames per event. Nine events were manual triggers during setup and testing (1,014 frames or 112 frames per event). The weather on this day was very windy and wet; 214 events are attributed to wind-induced camera shake or rain in the air or splattered on the camera enclosure window. In these events, 978 frames were recorded (five frames per event).
